March 20, 2024

Dear Beachcomber Inn HOA member:

The attached project programming report was issued by Lumos & Associates (a consulting firm located in South Lake Tahoe, CA) at the request of the Beachcomber Inn Board of Directors. This report was generated after Lumos & Associates evaluated the Beachcomber site per the scope specified by the Board. (See the Project Scope section below for details.) This project programming report is intended to assist the Board in evaluating the feasibility and priority of various infrastructure improvements at the Beachcomber Inn.

The attached programming report summarizes the conclusions reached by Lumos & Associates and Monarch Architecture. It covers two of the three major infrastructure components of the Beachcomber Inn site (i.e. the site building exterior makeover and the site retaining walls). The detailed programming for the Parking Lot replacement is not included in the programming report because only a very limited programming analysis has been done. Lumos is currently working on the parking lot assessment, which includes in-filling the well, replacement of the sewer and storm drains, and releveling and paving the parking areas. (A ro

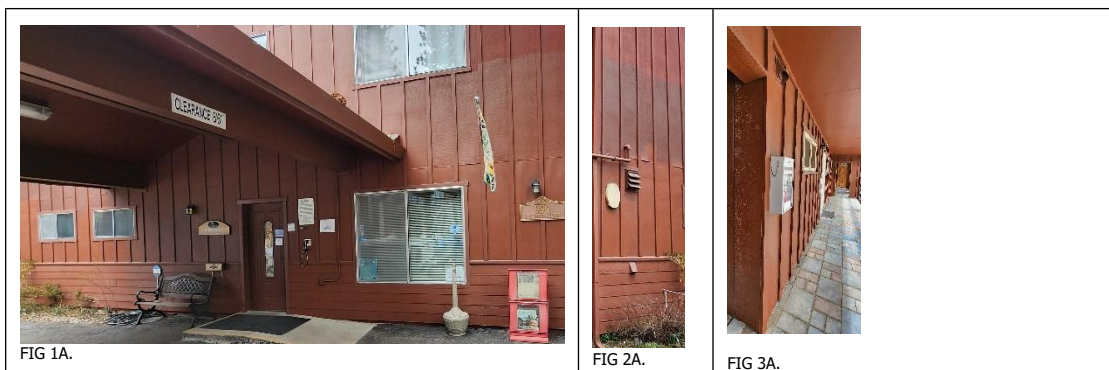
- **Existing Wood Siding:** The current siding is primarily board and batten (Fig. 1a-3a). The current condition appears to have limited issues. There does appear to be a number of locations where patches have taken place and the paint patches are evident (Fig. 2a).
 1. At minimum, repaint building with updated color that is consistent throughout the property. Additional inspection would be done to identify any particular locations of the siding that need any repair and replacement on a case-by-case basis. This

option would be the least cost sensitive but the life span for future work to the siding would more than likely be within the next 7-10 year timeframe.

2. Provide a hybrid in which the majority of the siding remains and is painted and additional accent siding is used to update the front façade and entry of the property. Similar to option one, the maintenance and future work to be completed would be in the 7-10 year timeframe.
3. The costliest option would be to replace the entire siding throughout the property. Various options include a fiber cement siding, stucco, wood siding. This option would have the longest return on future improvements. For instance, fiber cement board offers a 30 year limited time warranty on their siding product Hardie Board.

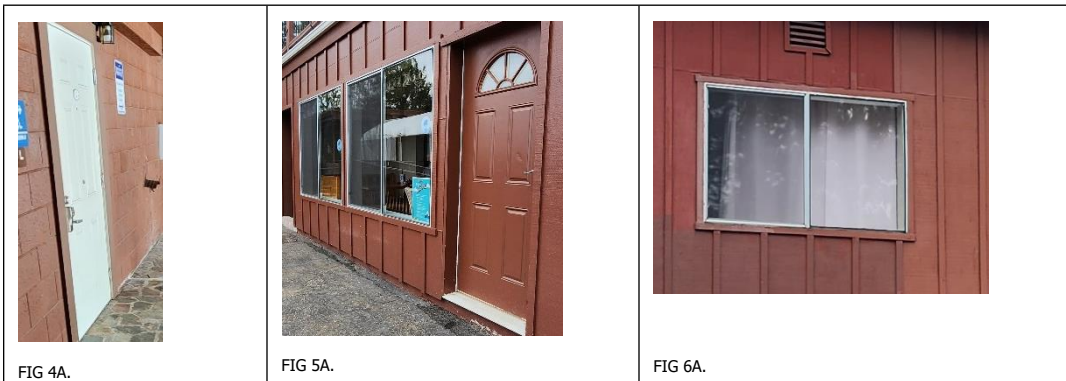
- **Windows and Doors:** There appears to be a mix of windows and doors throughout the property (Fig. 4a-6a); including vinyl and aluminum. It is our opinion this is due to various improvements over time. Door sills along the accessible path of travel should also be evaluated to make sure they comply with the profile and max ½" vertical rise.

1. At minimum, identify any windows or doors having waterproofing issues and replace. Also identify any doors that do not meet accessibility requirements including door sill issues and replace.

2. In addition to replacing windows and doors that are failing, replace windows and doors on front street façade.

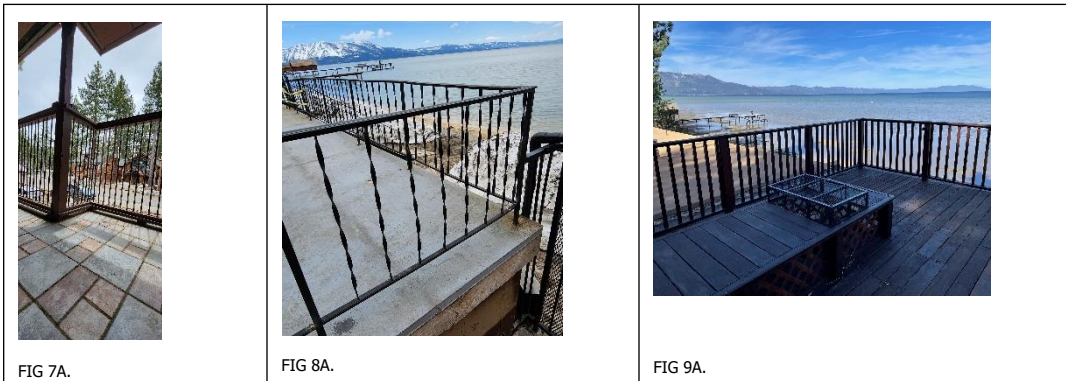
- **Guardrails:** There are three guardrail types currently utilized. The majority looks like it was done in the past 10 years and consists of vertical rebar pickets; this guardrail appears to meet code (Fig. 7a). The other guardrail (Fig. 8a) is located at the guest rooms closest to the lake: These guardrails are not up to date with code and replacement is highly encouraged from a safety standpoint. CBC requires walking surfaces with a 30" or greater elevation drop require a guardrail. The guard is required to be a minimum of 42" high and cannot have any openings that would allow a 4" sphere to pass through. The common use deck and ramps have a 2X2 vertical pickets (Fig. 9a) and appear to be in acceptable condition and meet the code.

1. At minimum, replace the non-code compliant guardrails.
2. Additionally replace the non-code compliant railing, paint the existing railing, and replace the top cap with a new wood piece for aesthetic purposes.
3. Replace all of the railings on the property to match and upgrade the look to help with the general architectural updates of the property.

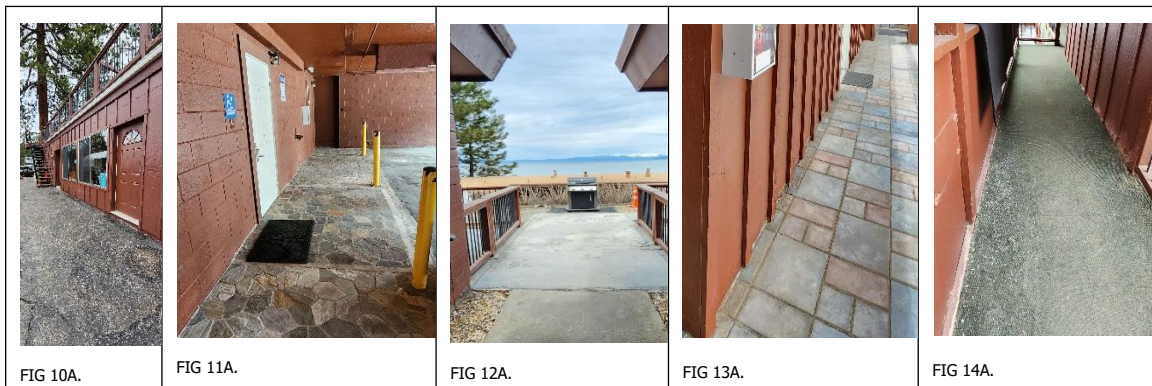
- Exterior Floor Finishes:** Only the exterior floor finishes were observed. There appears to be a number of different types of floor finishes throughout the property. Concrete, stone pavers and carpet were observed (Fig. 10a-14a). The three main aspects of the flooring that we identified are: accessibility (ADA) requirements, aesthetic and maintenance/failure locations. Properly detailing any replacement of flooring will be critical to ensuring no waterproofing issues in the future.

- At minimum, identify any current waterproofing issues and or failures of flooring and repair. Once a complete path of travel strategy has been developed identify the locations needing upgrades for ADA and remedy those locations only. Note max slope for an accessible path of travel is 2% with no more than a 1/2" rise.
- Complete the minimum for maintenance and ADA and also replace all public area walkway material to be consistent throughout property.
- Replace all flooring at exterior walks, guest balconies and public spaces. Although this option would be the costliest it would ensure a tight seal and help with eliminating future issues.

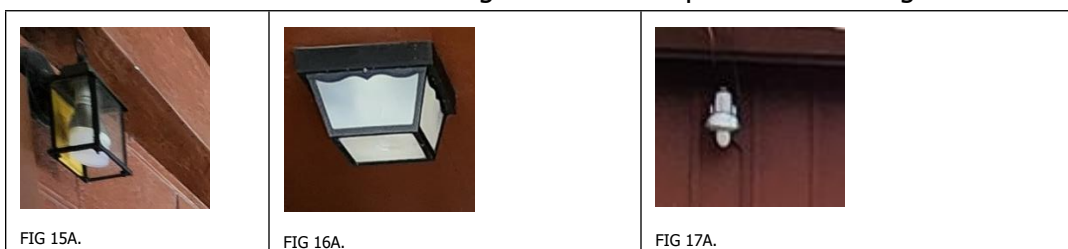
- **Exterior Lighting:** There were several different exterior light fixtures identified throughout the property. It also appeared that the current exterior lighting does not meet the CSLT and TRPA lighting requirements which effectively requires a dark sky fixture. Lighting appears to be insufficient. There are a number of locations that could benefit from additional lighting. Both from a wayfinding and security standpoint. Exterior Lighting to be replaced/added will also be required to meet California Energy Code requirements.
 1. At minimum, replace the non-code compliant light fixtures and use one consistent fixture type/ style throughout the property.
 2. Replace non code compliant and identify a key number of locations that could utilize additional lighting.
 3. Provide a comprehensive lighting plan that includes landscape, sidewalk, and building lighting throughout the property.

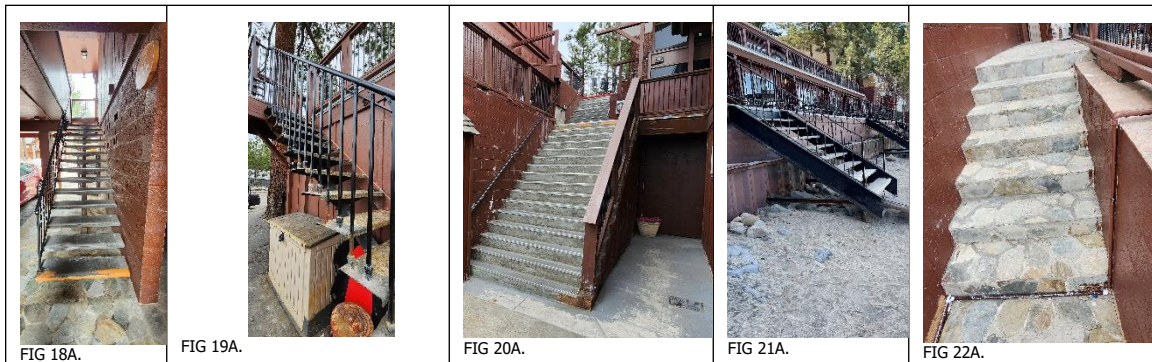
- **Stairs and Handrails:** There are a number of stairs on the property (Fig. 18a-22a). It was observed that none of them meet current codes. Both Accessibility and Life Safety dictate the requirements of stairs including the rise/run, handrail location/profile/height, allowance of open risers, stair width, lighting and warning strips. Once a site plan and as-builts have been completed, it is recommended a complete study of the existing stairs be done and a design completed to update all the stairs on the property.
 1. Only replace stairs that are modified under the special assessment.

2. Bring all stairs up to current codes and provide a consistent guardrail/ handrail design for all stairs.

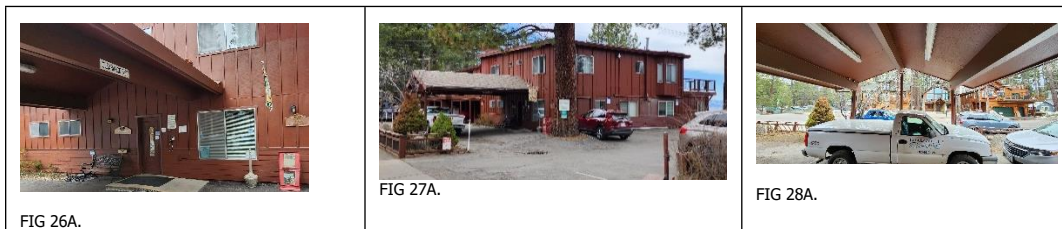
- The HOA has identified the Portico (Fig. 26a-28a) as being an important feature to be upgraded; both from a functional and an aesthetic standpoint. A previous study had been conducted by Design Workshop to identify a new design for the entry structure, which was provided to us for review and reference. The HOA Members expressed that they liked the concepts/architecture that had been presented.

The existing structure lacks an expression of architecture. It sheds water/snow over the entry/exit. As identified in this report, the existing portico is sitting in the setback; leaving it in its current location is encouraged. There was also a request from the HOA to create a lock box kiosk for guest arriving after hours. The existing ramp to the entry is not ADA compliant and would need to be redesigned. Once a site plan has been completed a review of how to modify the grades to assist in remedying the issue should be completed.

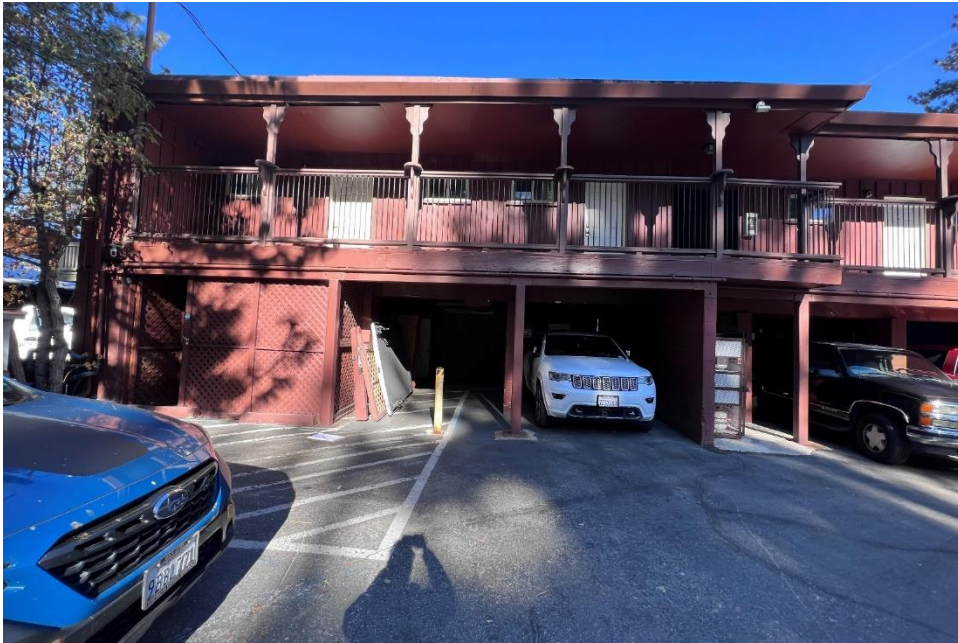
Photo 1 – Carport looking north

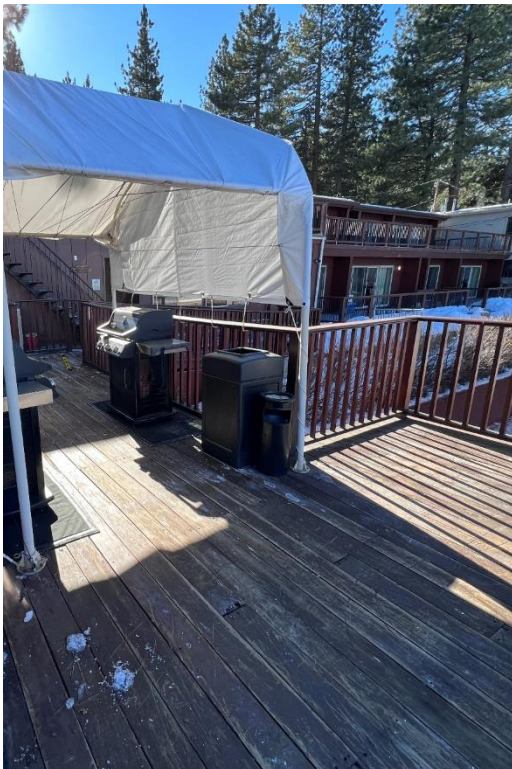
Photo 2 – Rooftop Deck

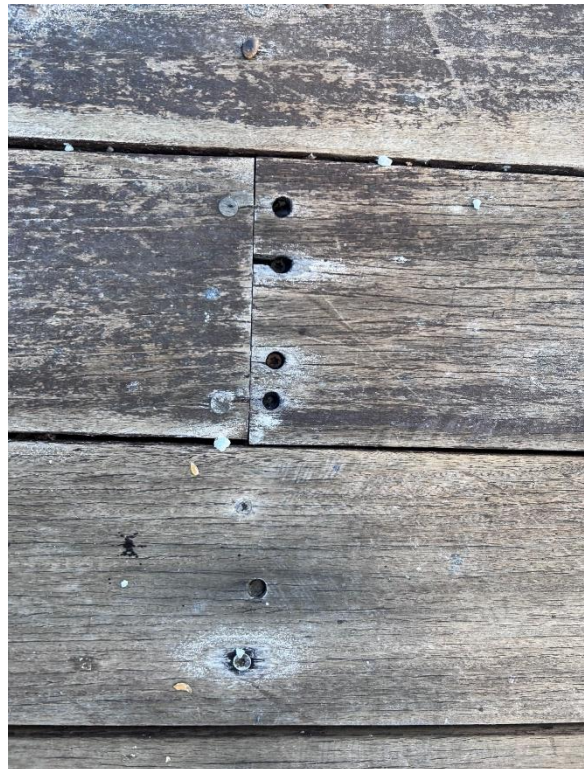
Photo 3 – Deck attachment

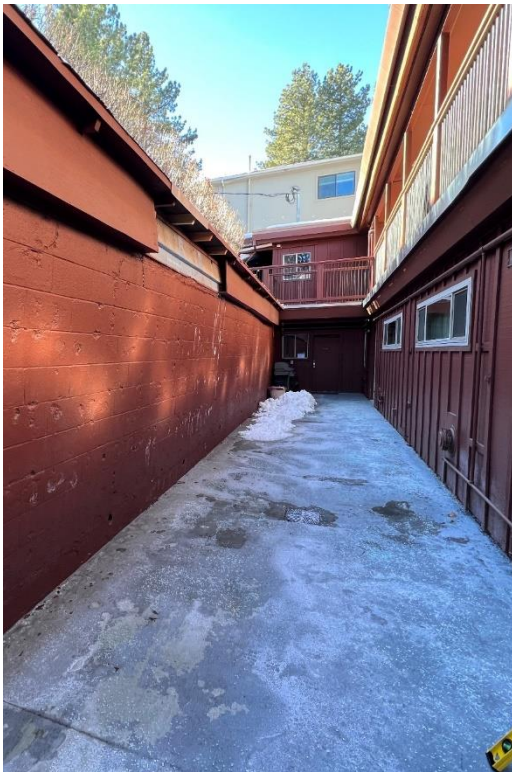
Photo 4 – Lower Retaining Wall

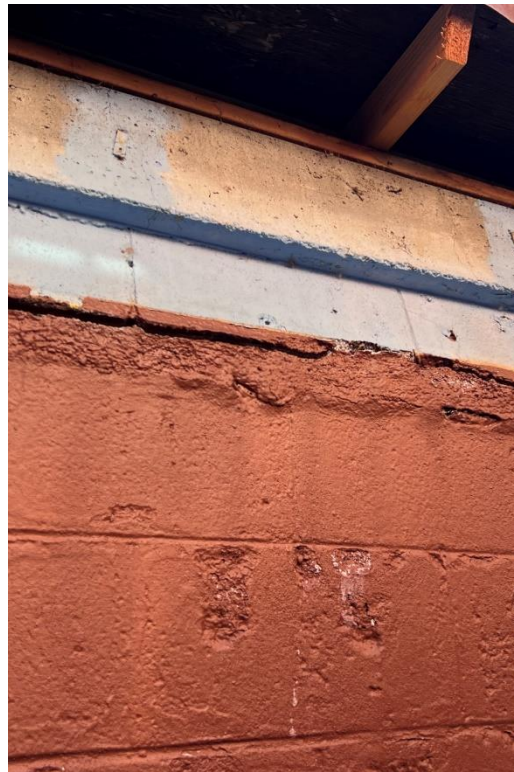
Photo 5 – Horizontal crack along the top of wall

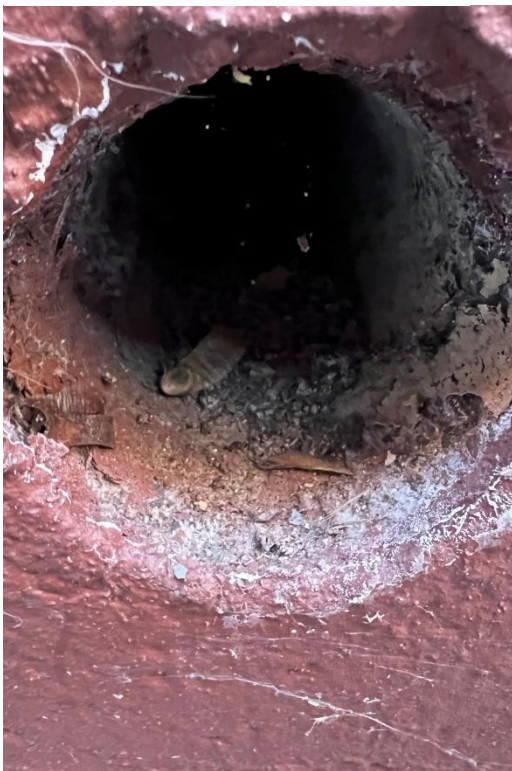
Photo 6 – Weep hole without evidence of moisture

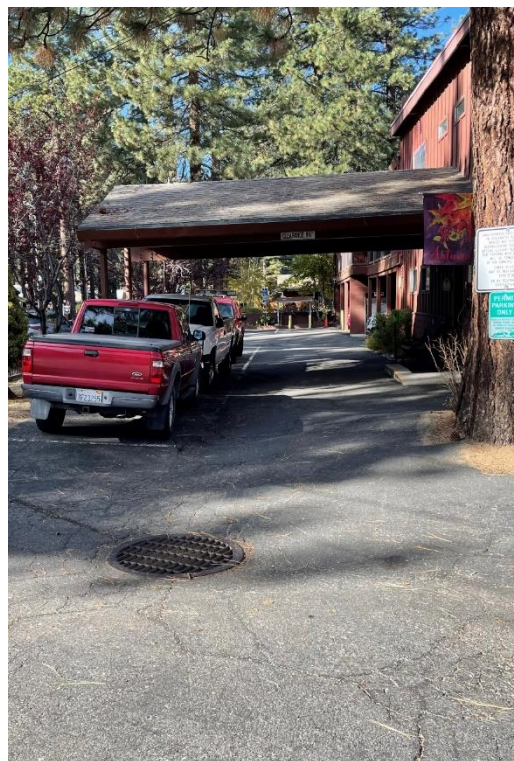
Photo 7 – Existing Porte Cochere

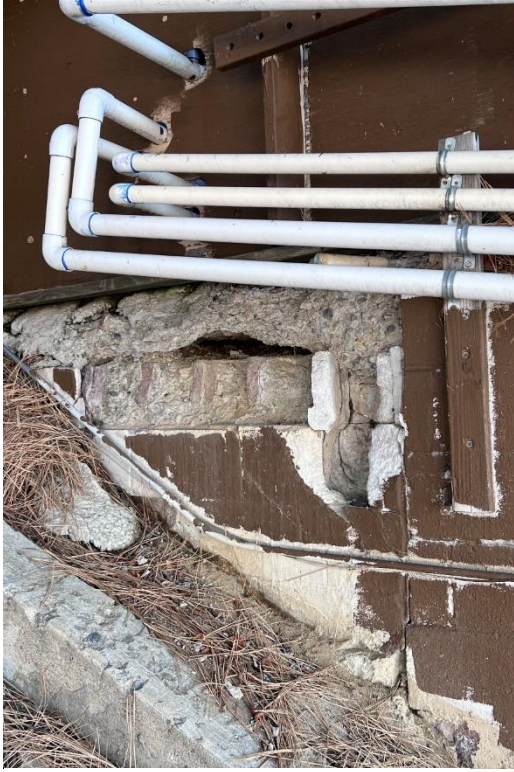
Photo 8 –Spalling CMU wall on
North-East corner of Pool Deck
