March 20, 2024

Dear Beachcomber Inn HOA member:

The attached project programming report was issued by Lumos & Associates (a consulting firm located in South Lake Tahoe, CA) at the request of the Beachcomber Inn Board of Directors. This report was generated after Lumos & Associates evaluated the Beachcomber site per the scope specified by the Board. (See the Project Scope section below for details.) This project programming report is intended to assist the Board in evaluating the feasibility and priority of various infrastructure improvements at the Beachcomber Inn.

The attached programming report summarizes the conclusions reached by Lumos & Associates and Monarch Architecture. It covers two of the three major infrastructure components of the Beachcomber Inn site (i.e. the site building exterior makeover and the site retaining walls). The detailed programming for the Parking Lot replacement is not included in the programming report because only a very limited programming analysis has been done. Lumos is currently working on the parking lot assessment, which includes in-filling the well, replacement of the sewer and storm drains, and releveling and paving the parking areas. (A ro

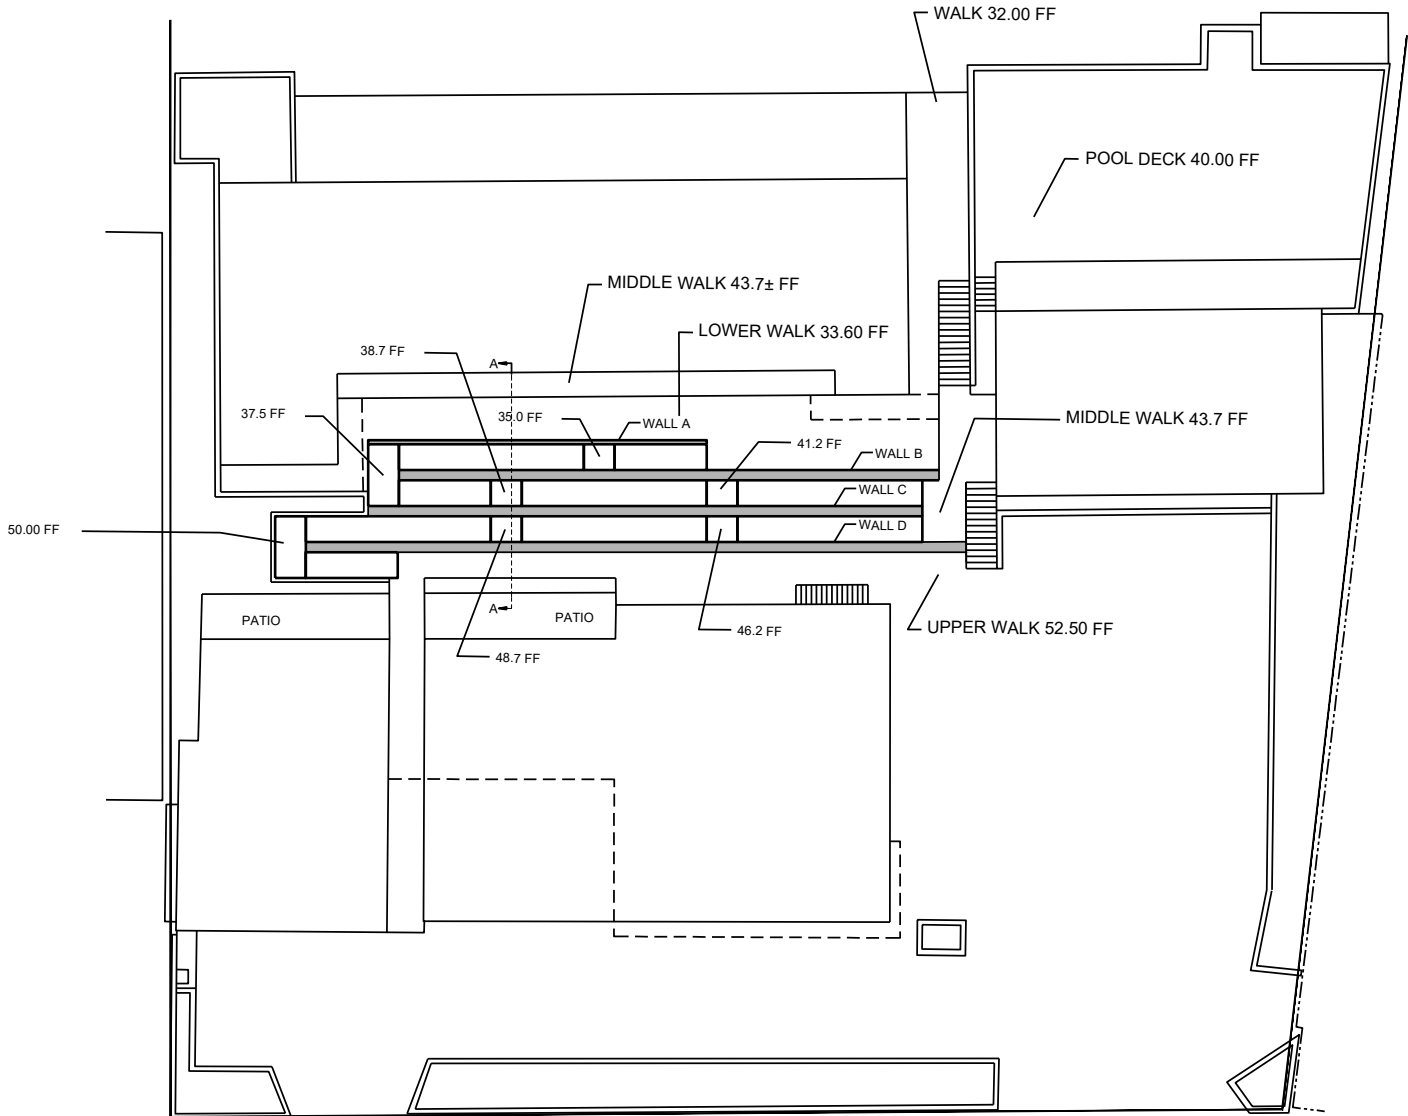
**FIG 1 : PROPOSED PLAN VIEW OF NEW
RETAINING WALLS WITH RAMP**

At this point, we advise monitoring the retaining wall's tilt frequently for any new indications of damage. Additionally, as a permanent solution we recommend replacing the current system with an engineered retaining wall system. As part of this replacement plan, we have explored the possibility of integrating an ADA accessible ramp into the current retaining wall location. We have worked with Brian Martone from Monarch Architecture to develop a concept of the proposed ramp, see figure 1.

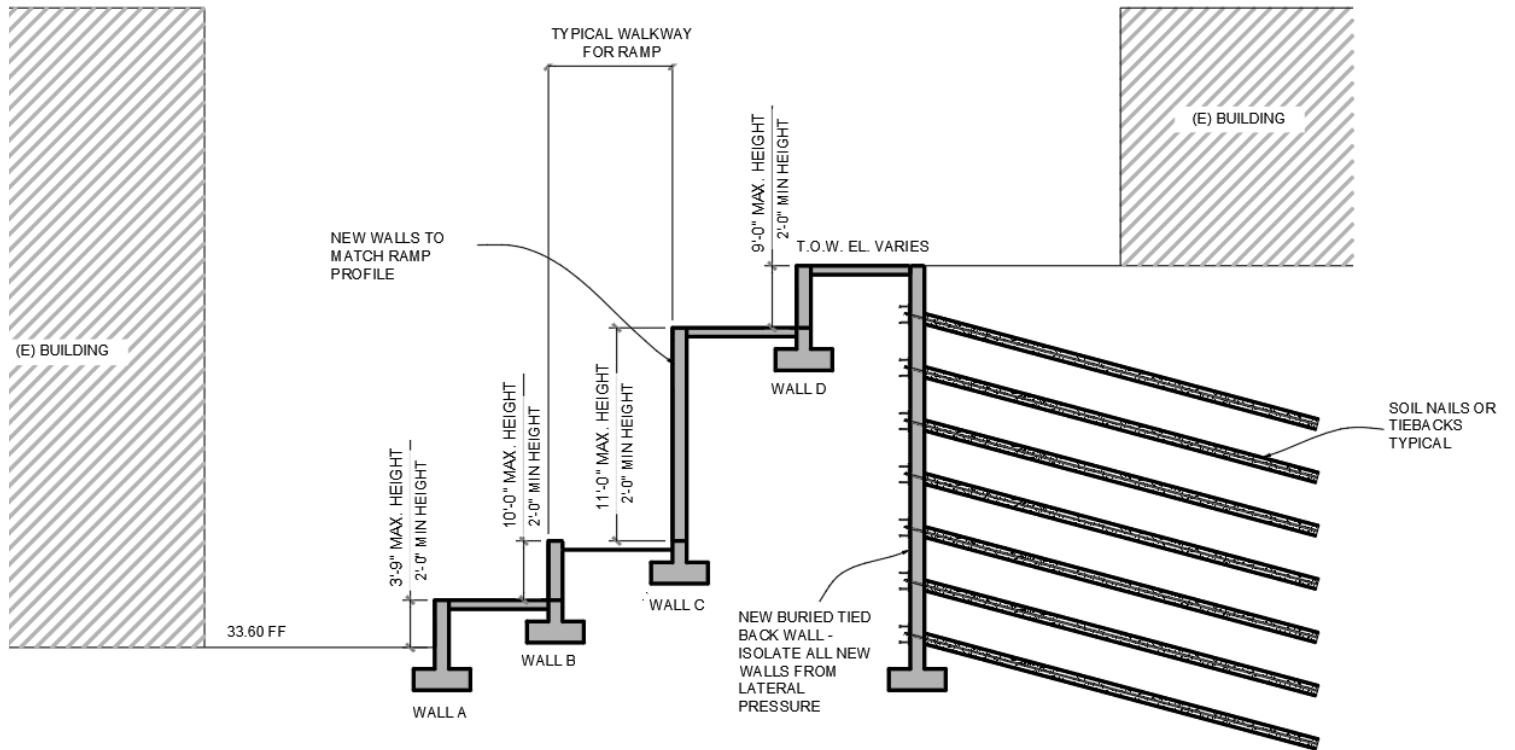
**FIG 2 : PROPOSED SECTION VIEW OF NEW
 RETAINING WALLS WITH RAMP**

Structurally, the new system will require demolishing the existing walls, elevator walls, and installing a new tied-back full height retaining wall adjacent to the upper building, see figure 2. A tied back retaining wall consists of a concrete wall supported by helical anchors or grouted tiebacks. This system utilizes the mass of soil behind the wall to stabilize it, eliminating the need for a large foundation. While the new full-height wall is being built, existing retaining walls can be used to stabilize the soil mass. The tied-back wall will isolate most of the lateral earth pressure from the ramp walls. The ramp walls will have a tapered top to match the slope of the ramp. To determine the appropriate depth of penetration for these tied-back walls, a comprehensive geotechnical study will be required. The dimensions for the current concept are approximate and are based on field measurements and topographic survey drawings by TA Turner and Associates, project number 9012, and dated 06/18/1990. We also recommend conducting a 3D survey of the area to carefully design the horizontal and vertical layout of the ramp and ensure that all necessary clearances are met.
